9/11 – Acceleration Study Proves Explosive Demolition

Frank Legge (Ph D)
Logical Systems Consulting
Perth, Western Australia.
flegge@inet.net.au

Version 2.0

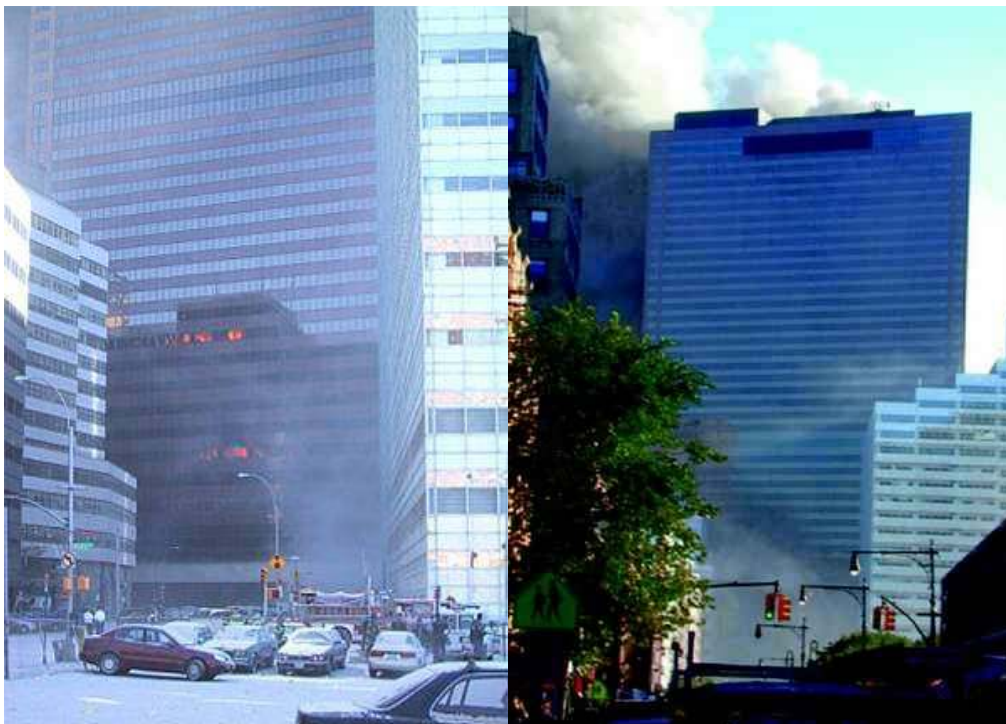
Small fires can be seen in the photograph on the left, taken in the mid-afternoon. In the whole area where the view is clear there are no broken windows. The photograph on the right was taken later, just prior to the collapse.² Again we see no sign of broken windows. This is of particular interest as a hot fire will break glass. The white cloud is probably rising from the rubble of the twin towers, known to be smoking, located just to the south of WTC 7, but the possibility that fires on the south face of the building are contributing to it must be examined.

2. This photo is from the FEMA report, chapter 5. That it is late in the day can be deduced from the direction of the sun and the fact that the street lights are on. Below is a photo taken from almost the same position after the collapse had started. It can be seen that the shadow on the foreground building is at almost the same angle as in the one taken before the collapse. This was close to equinox, at which time shadow angles move 15 degrees per hour. These photos can be no more than a few minutes apart; no time for a severe engulfing fire to occur.

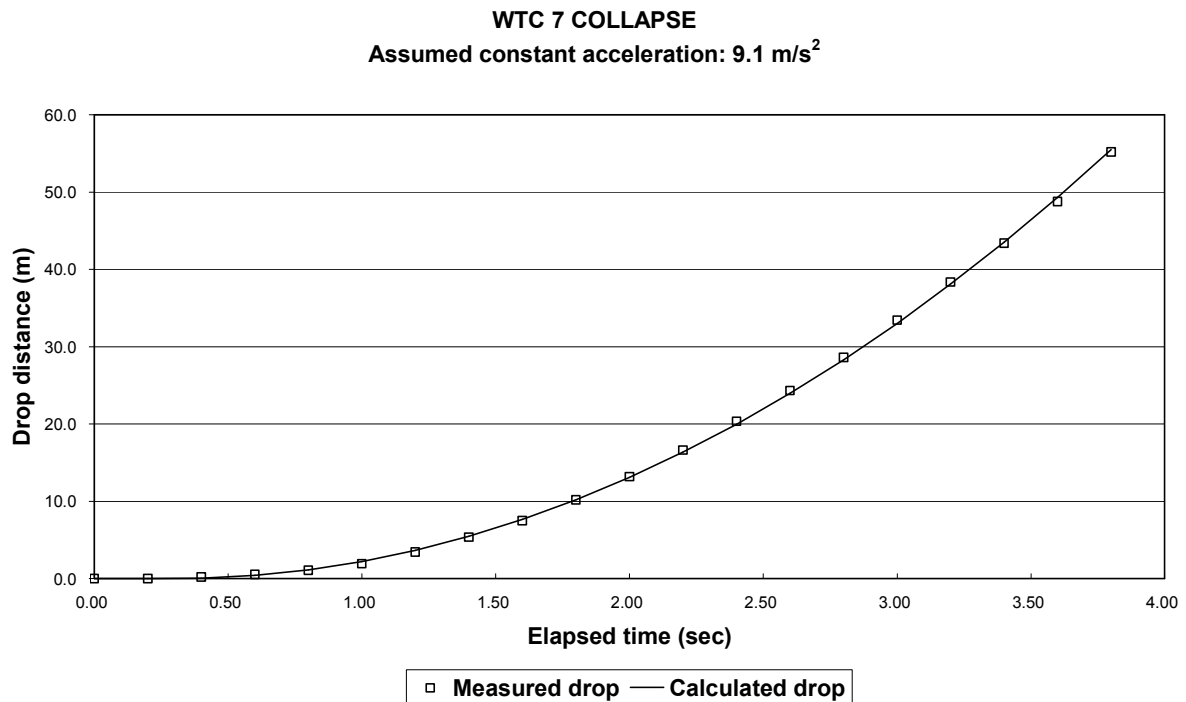
initially negligible motion of the corner nearest the viewer but from the moment it starts to move the collapse of this corner is uniform and close to vertical free fall as shown in the graph below.

The observed acceleration, 9.1 m/s^2 , if maintained, would bring the roof to the ground in 6.2 seconds, very close to free fall in a vacuum, 6.0 seconds. There is no sign of the slow start that would be expected if collapse was caused by the gradual softening of the steel.

The graph above fits the data points closely. The line is drawn with an equation which assumes constant acceleration.⁷ That means that the net downward force was constant. As gravity is constant this implies that the upward force provided by the structure was also constant. It is inconceivable that fires could heat the structural supports so uniformly throughout the height of the building that the collapse would encounter uniform vertical resistance. Fires by their very nature tend to creep from place to place as they run out of fuel and move to fresh sources, leaving the burnt out area to cool down. Steel regains strength as it cools.

where s is the distance, a is the acceleration and t is the time. The fitting of the equation to the data was done using a least squares method. This gave a value of 9.063m/s^2 , which has been shown to two significant figures in the text and graph.

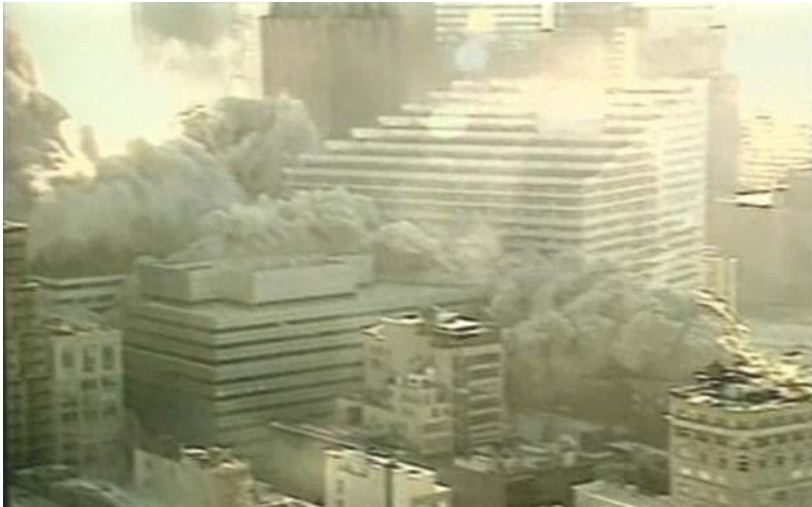
4. The frame below shows the dust running rather like a liquid along the “valley” between the buildings indicating that, for dust, it is unusually dense. The high density is also indicated by the speed of flow seen in the video

It is also worth noting that the behaviour of the dust cloud after the collapse was unusual. It rolled rapidly away hugging the ground, suggesting that it was denser, and thus more propelled by gravity, than is normally observed in controlled demolitions.⁴ This is clearly reminiscent of the energetic dust clouds rolling from the twin towers, though the effect is not as pronounced. One suspects that more explosive than usual was employed in all three buildings to guarantee that the collapse would be well controlled and thus would exhibit no hesitation or tendency to lean. The extra explosive would pulverize more of the concrete than usual and so produce a denser dust cloud than seen in commercial demolitions.
